Conservation History and Processes

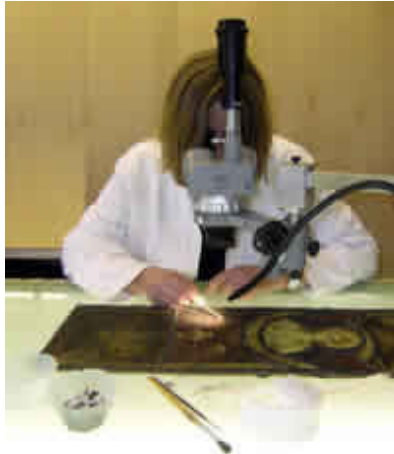
Once familiar with the particulars of the panel, the conservator can begin by carefully removing surface accretions on the glass, which may involve dry cleaning or the gentle rolling of a wet cotton wool bud over the surfaces. Dependent on the condition of the paint pigments, this procedure can be carried out with the naked eye, but in more delicate areas, the use of a microscope becomes imperative.

The next step may then involve the removal of more tenacious surface accretions with a scalpel, a glass fibre brush, or ultimately with the airbrasive equipment, which are all tools requiring the patience and skill of an experienced conservator.

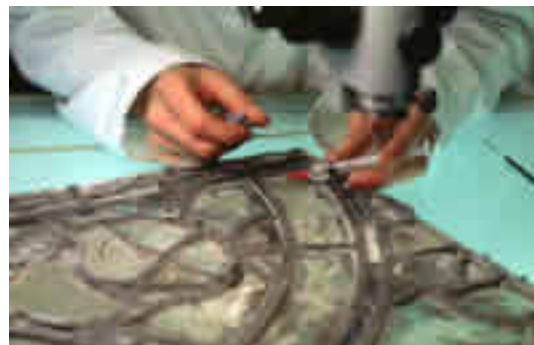
Regarding the glass, this means that single cracks will be stabilised in situ with an acrylic or epoxy resin of very low viscosity so that it can penetrate the fracture.

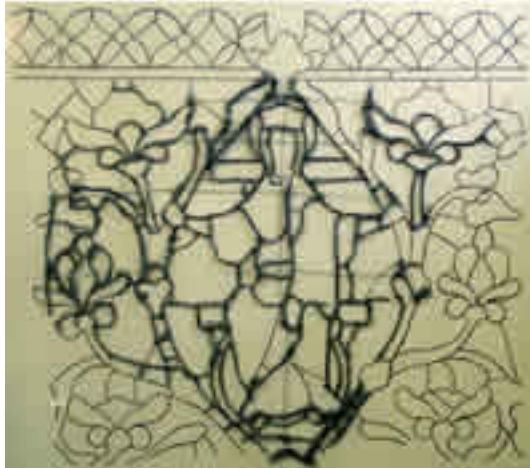
Multiple cracks are repaired by removing the glass fragments from the leadwork, by edge-bonding them with a resin or a silicone and by backplating the re-assembled piece to give it additional strength before reinserting it into the leadwork.
